Manhole Inspection Summary

Manhole # S31K__006MH

Insp Date: **11/23/08 10:57 AM**

Location Address: **604 Eislen St**

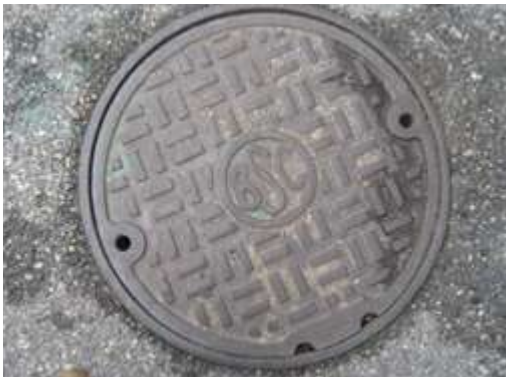
Misc

cover

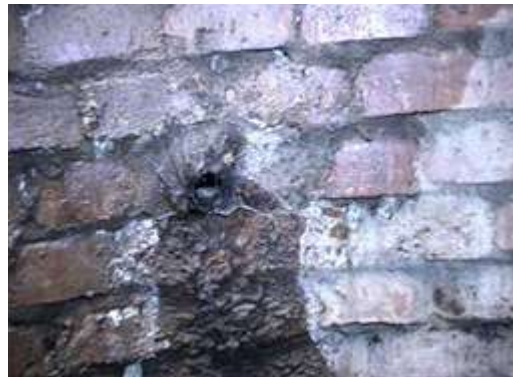
Defect 4

Infiltration: ☐ None ☐ Joint ☐ Cracks ☐ Mortar ☐ Roots ☒ **Wall**

corbel infiltration at wall at broken blow-out

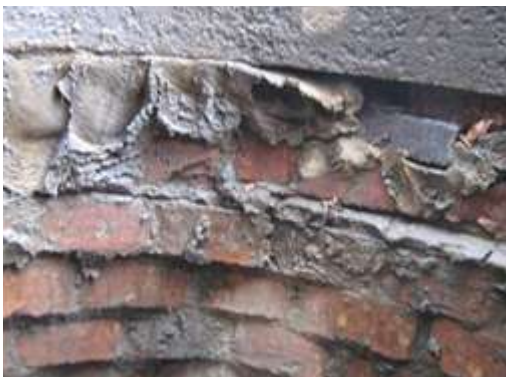
Defect 3

Condition: ☐ Sound ☐ Cracked ☐ Root Intrusion ☒ **Loose Brick** ☒ **Deteriorated**

chimney loose bricks and deteriorated

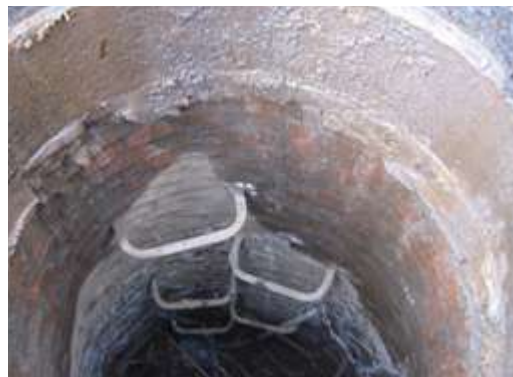
Defect 2

Infiltration: ☐ None ☒ **Joint** ☐ Cracks ☐ Mortar ☐ Roots ☒ **Wall**

chimney infiltration at frame joint

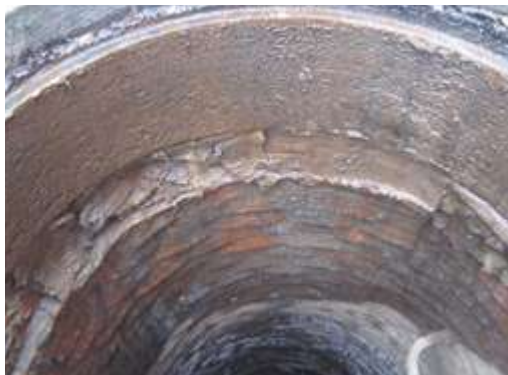
Defect 1

Condition: ☐ Sound ☐ Cracked ☒ **Leaks**

frame infiltration at cover

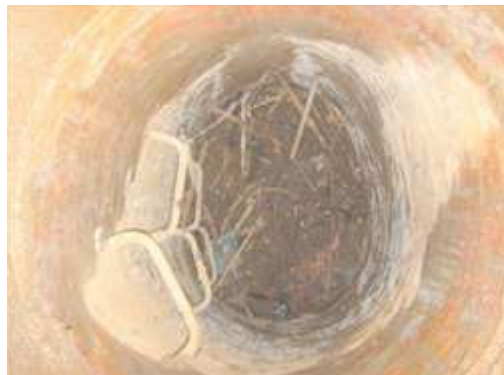
Defect 5

Condition: ☐ Sound ☐ Cracked ☐ Root Intrusion ☐ Deteriorated ☐ Leaks ☒ **Debris**

heavy channel debris

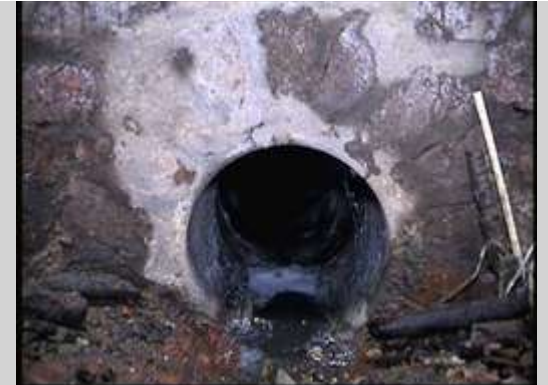
12 O'Clock Outflow

8 in. Circular Gravity Sewer
Pipe Out @ 12 O'Clock
